Manhole Inspection Summary

Manhole # S41E__069MH

Location Address: **1400 lombard st**

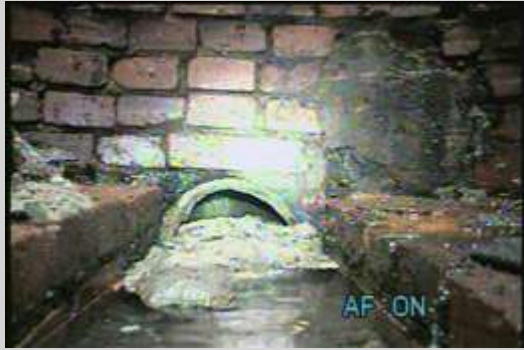
6 O'Clock Inflow

Deposits: ☐ None ☐ Mud ☐ Sludge ☒ **Debris** ☐ Grease

Silt Depth: **5** (in.) Deposits Extent: **Heavy**
